RL-TR-96-117
In-House Report
October 1996

ROME LABORATORY ANALYSIS OF COMPONENTS FOR ELECTRONIC TECHNOLOGIES FOR CLEANING IN 1996 AND BEYOND

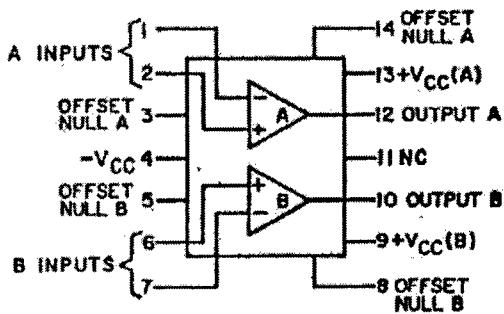
Figure 1: Package Pinout of LM747

A single LM747 (SN012 U23) operational amplifier manufactured by National Semiconductor was tested to verify electrical functionality. This device is part of the ODS effort and was classed as an electrical failure. No information was given regarding the test conditions and test circuit configuration.

This device was determined to be functional under these conditions. The electrical test results will vary when different test conditions and test circuits are used. Additional information is required to determine if device failure only occurs under specific conditions.

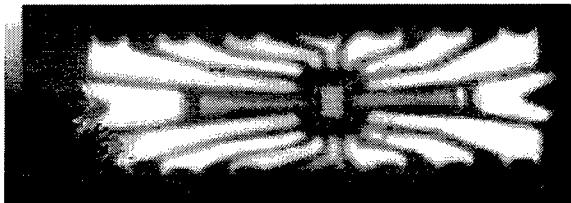
Figure 1. C-SAM of PLASTIC Device

PLASTIC vs RWOH: All the devices exhibited good bonding integrity at the lead frame, die surface and die paddle bottom. The RWOH devices have delaminations on the paddle surface around the die and the PLASTIC devices did not. However, the PLASTIC devices had a different paddle and lead frame than all of the other devices. In addition, the die paddle surface for all of the PEMs of the RWOH type was delaminated around the die. Figures 1 and 2 represent C-SAM images of each part type. The black area is a delamination at the mold compound/die paddle interface.

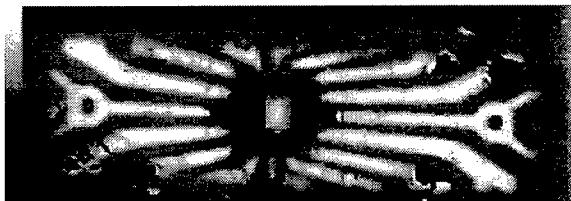
Figure 3. C-SAM of PLASTIC S Device

PLASTIC S vs RWOH S: The PLASTIC S devices had more delamination than the RWOH S devices with the exception of the CONTROL device. However, there aren't enough devices to say if the RWOH devices would be more reliable. A lot of the devices exhibited delamination along the lead frame for pins 3, 4, 5, 10, 11 and 12 which is the shortest pathway to the die surface from outside the package. Figures 3 and 4 represent C-SAM images of each part type. The black areas are delaminations at the mold compound/lead frame or mold compound/die paddle interface.

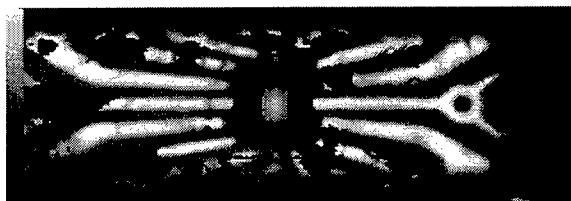
Figure 5. C-SAM of PLASTIC A Device

PLASTIC A vs RWOH A: The PLASTIC A and RWOH A devices exhibited the most delamination of all the devices. Many of the devices exhibited delamination along the lead frame for pins 3, 4, 5, 10, 11 and 12 which is the shortest pathway to the die surface from outside the package. This delamination could have a significant reliability effect if contamination can find its way to the die surface. Figures 5 and 6 represent C-SAM images of each part type. The black areas are delaminations at the mold compound/lead frame or mold compound/die paddle interface.
